## Cleanup Update

# Milltown Reservoir Sediments Superfund Site

Issue #77

April 1, 2009

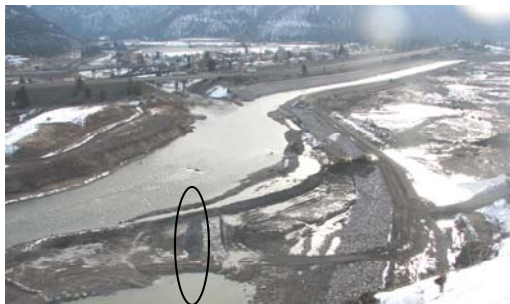
9 am: Pre-breach view of the project area. Oval shows area where coffer dam will be breached.

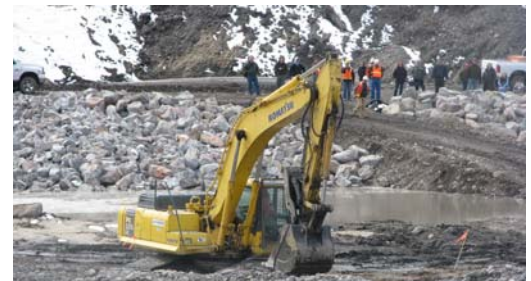
2 pm: Removing material to begin the breach of the spillway coffer dam and divert the Clark Fork and Blackfoot Rivers into the new channel

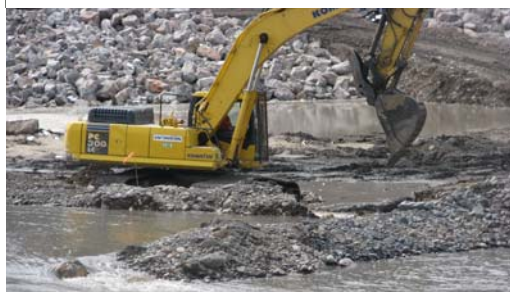
Coffer dam is breached! Clark Fork and Blackfoot Rivers begin to flow into the new channel.

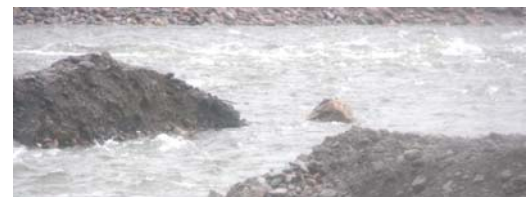
Flow into the new channel increases; By late Friday, about 20% of the river flow was in the new channel (as projected). By Monday, about 70% of the river flow had been diverted into the new river channel at the base of the bluff.

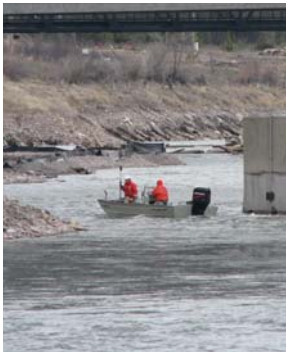
In the photo at the left, US Geological Survey staff are shown navigating the Blackfoot River as they set up equipment to measure river velocities during spring flows. EPA is funding this work to help estimate the ability of fish to swim upstream (fish passage) on the Blackfoot River during high flows.

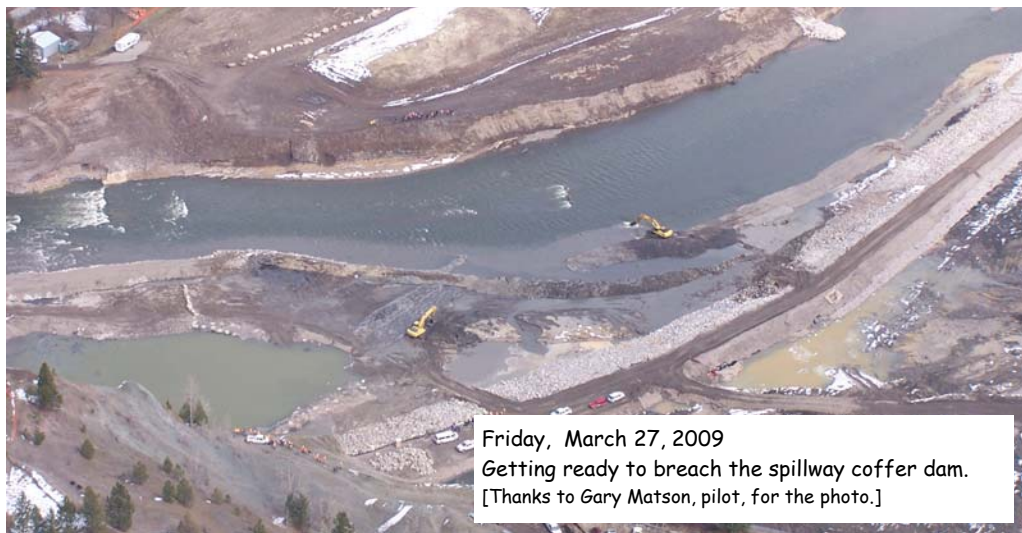
Friday, March 27, 2009  
Getting ready to breach the spillway coffer dam.  
[Thanks to Gary Matson, pilot, for the photo.]

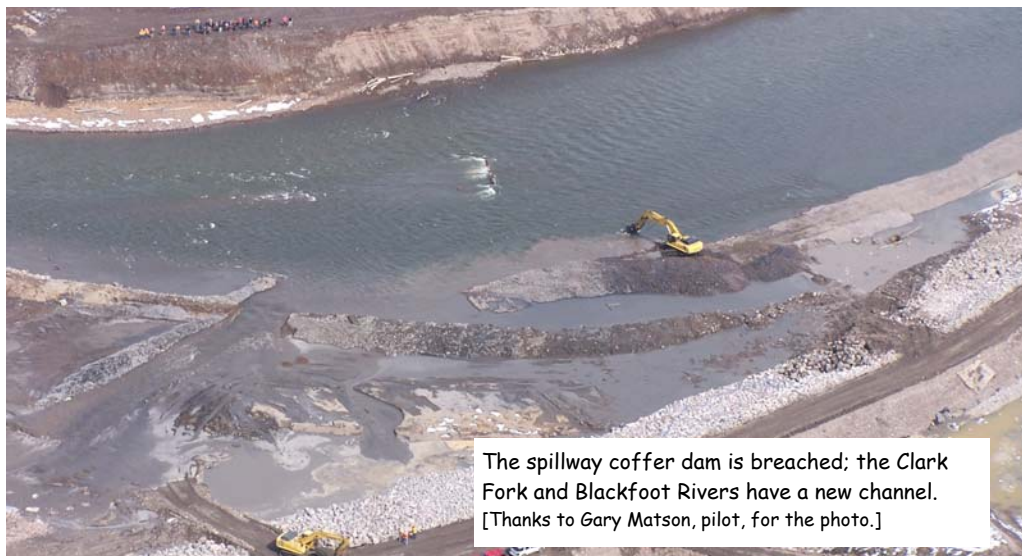
The spillway coffer dam is breached; the Clark Fork and Blackfoot Rivers have a new channel.  
[Thanks to Gary Matson, pilot, for the photo.]
